Home Inspection Report

5095 S 2800 W, Roy, UT 00000

Wednesday October 26, 2016

TM02432Thedell

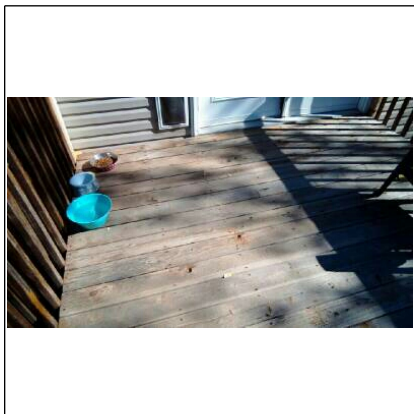
Comments --Deck has exposed wood. Recommend paint or stain as needed.

Deck needs paint

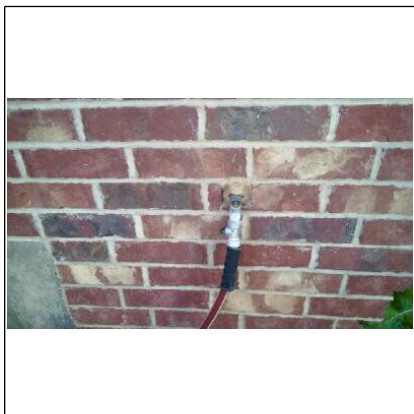
Comments --Front exterior faucet handle missing. Recommend replace.

Faucet handle missing

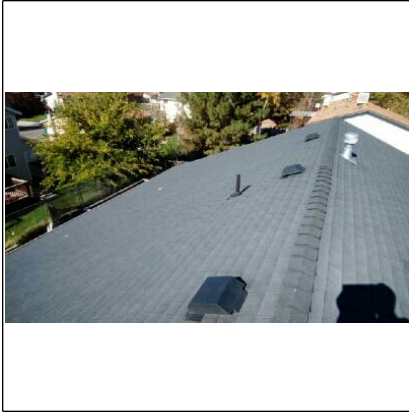
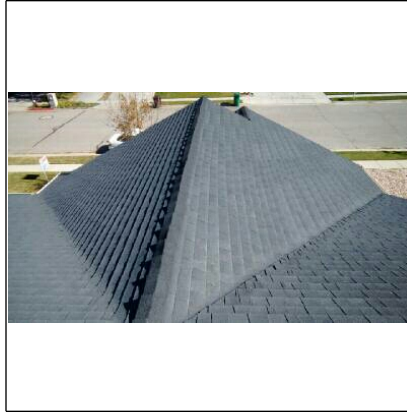
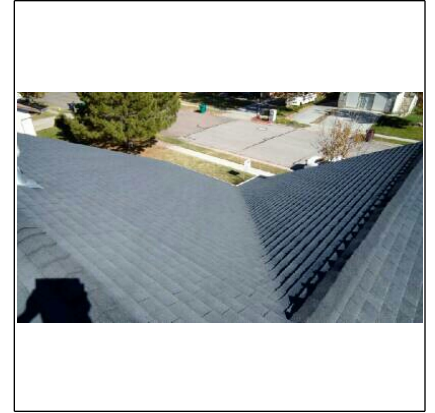
Roof in good condition

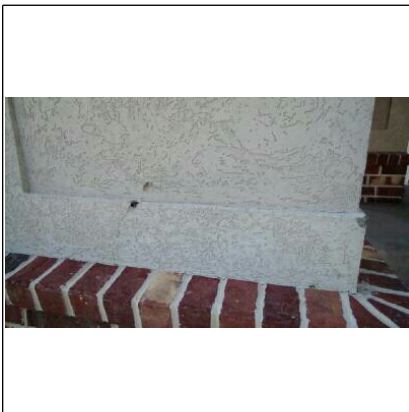
- Minor peeling paint bottom of exterior door trims. Recommend paint as needed.
- Multiple small holes stucco near front porch. Recommend repair by qualified contractor.

Small holes in stucco

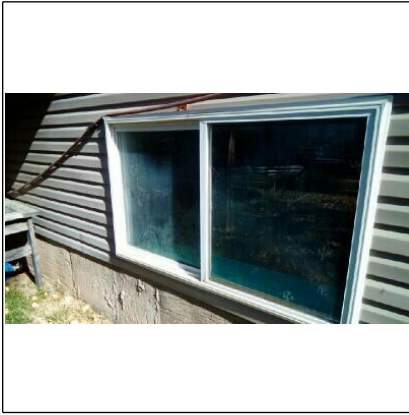
Comments --Multiple missing or damaged window screens. Recommend replace.

Missing window screens.

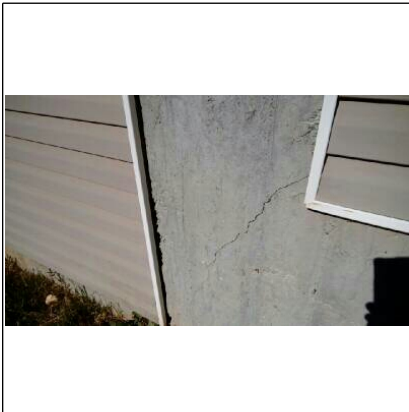
- Basement exterior door weather stripping missing. Recommend replace.
- Small crack in foundation south side. Recommend seal by qualified contractor and monitor.

Crack in foundation

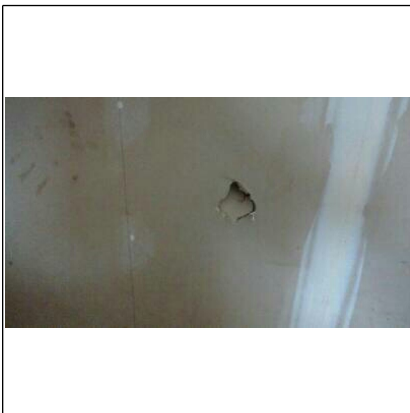
- Hole in drywall garage north wall. Recommend repair as needed.
- Moisture damage under kitchen sink - appears past leak on drain. Recommend repair as needed.

Hole in garage wall.

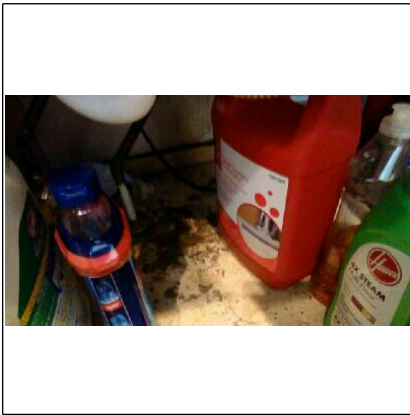
Comments --Signs of past leaking under kitchen sink. Recommend monitor.

Moisture damage under kitchen sink

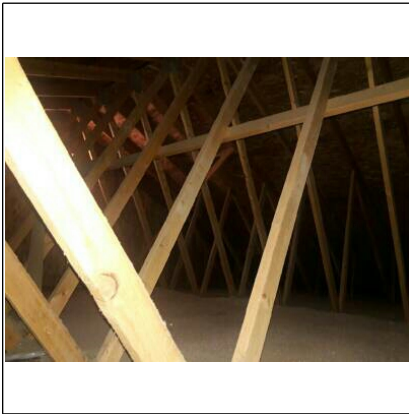
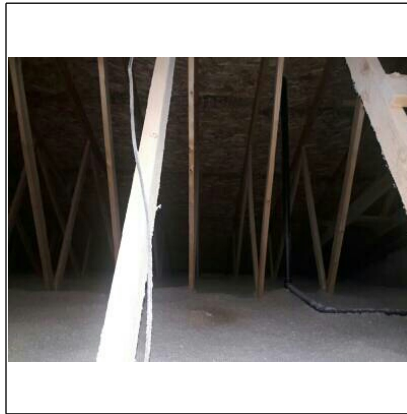
No issues in attic

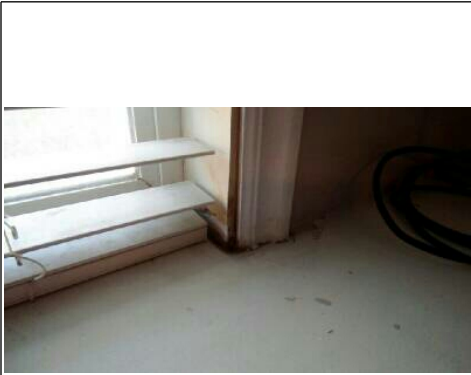
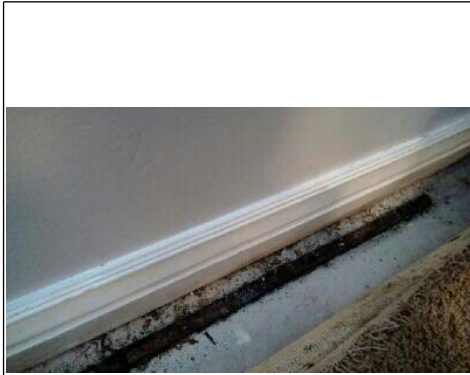
- Water damage basement family room north east corner on baseboard and window trim - appears past water through window. Recommend evaluate by licensed contractor and repair as needed.

Water damage basement family room

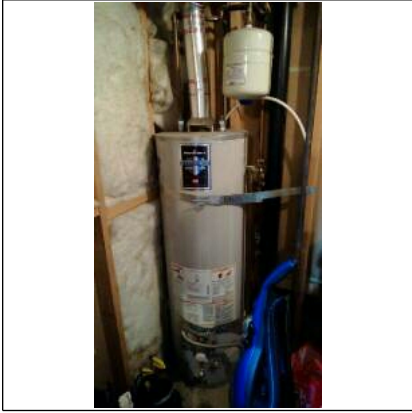
- Water heater is 14 years old. Recommend budget to replace in near future.

Comments --Water heater is years old. Recommend budget to replace in near future.

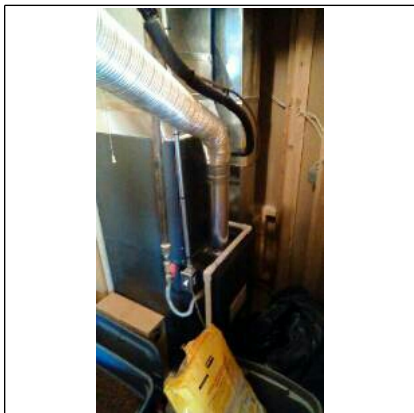
- System not operated due to** N/A Exterior temperature Other: .
- Comments** --Furnace filter dirty. Recommend replace.
 --Furnace and air conditioner appear not serviced in sometime. Recommend service by licensed contractor.
