Home Inspection Report

5095 S 2800 W, Roy, UT 00000

Wednesday October 26, 2016

TM02432Thedell

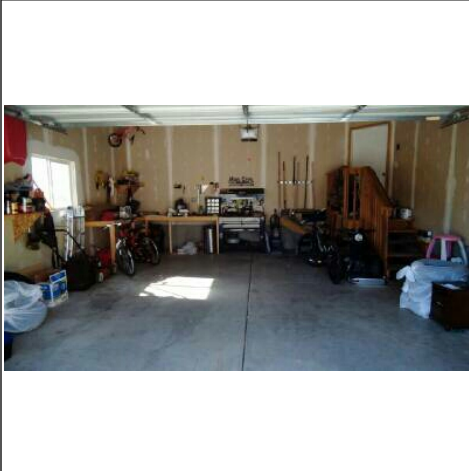
Garage/Carport Photos

Hole in garage wall.

- Hole in drywall garage north wall. Recommend repair as needed.
- Moisture damage under kitchen sink - appears past leak on drain. Recommend repair as needed.
